H-pack, Davy Way, Llay, Wrexham, LL12 OPG

Arboricultural Implication Study

September 2022

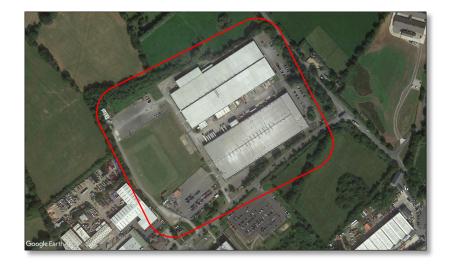
Figure 1

The site is a current manufacturing unit with open grassed areas and areas of hard standing on the Llay Industrial Estate, Llay, Wrexham (Figure 1).

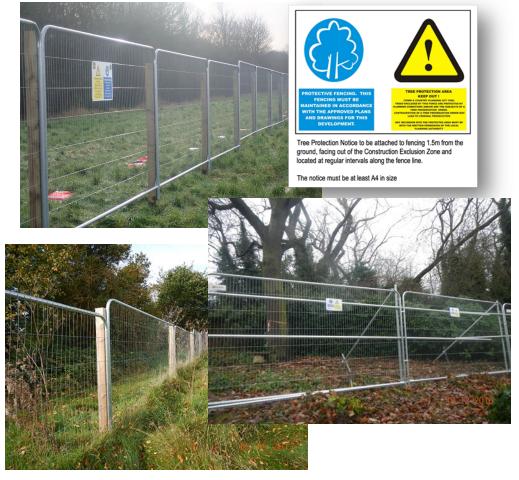
Due to the nature of the works, standard BS 5837 fencing will be used. The Construction Exclusion Zone fence will be heras fence panels fixed to a scaffold framework. Alternatively, heras panels fixed to timber posts. The location will be marked on site by the Arboricultural Consultant and are also shown on the Drawing No. – TPP/4682/Y/300. The requirement will be assessed on a weekly basis by the ACoW.

- Heras fencing fixed to a scaffold framework or timber posts as illustrated.
- Fencing installed at locations shown on the plan (TPP/4682/Y/300) and marked on site.
- Location and adequacy signed off by Arboricultural Consultant and LPA advised.
- Tool Box Talk make construction staff aware of the importance of areas by site manager.
- > Signs to be erected advising of the area's importance.
- > Fence to be adjusted as noted in the Construction Timetable.

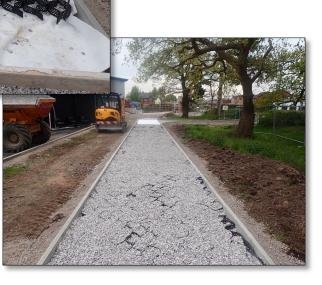
Construction Exclusion Zone No dig

- The No dig path/drive is to be designed by a reputable supplier of three-dimensional products used for such purposes.
- The contractor is required to follow the method statement supplied by the product supplier.
- The contractor is required to meet with the ACS Consulting at the site prior to beginning work to review all procedures, access and haul routes, storage and tree protection measures.
- Tree contractors and not construction personnel must perform additional tree pruning required for clearance during construction.
- ➢ Works to be overseen by ACoW.

The pavement from the south will be continued into the site. Where it is located in the RPA of retained trees, it will be constructed using three-dimensional geo-grids.

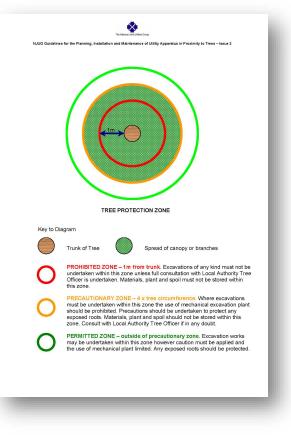
Services - NJUG 4.2

Work area to be marked out in accordance with NJUG 4.2.

- > The precautionary area is to be identified.
- Suitable method of service installation to be identified this may include Hydro Vacuum & Suction Excavation or Compressed Air Displacement.
- Location and adequacy signed off by the ACoW and the LPA advised.
- > Works to be monitored by ACoW.
